Manhole Inspection Summary

Manhole # S29KK_011MH

Location Address: **1727 NORTH AVE**

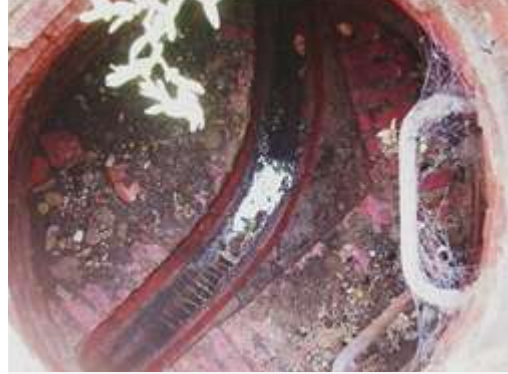
Top View

Corroded and missing steps. Evidence of surcharge - Bench debris.

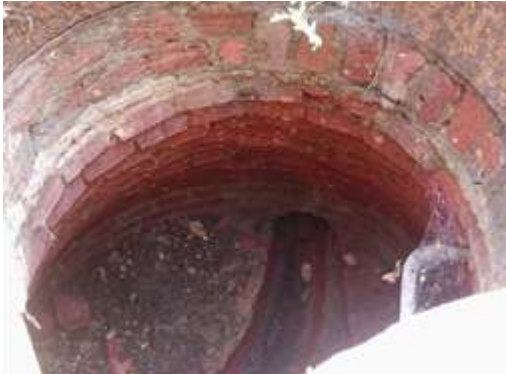
Defect

Adjustment deterioration, root intrusion and infiltration. Corbel and Barrel infiltration.

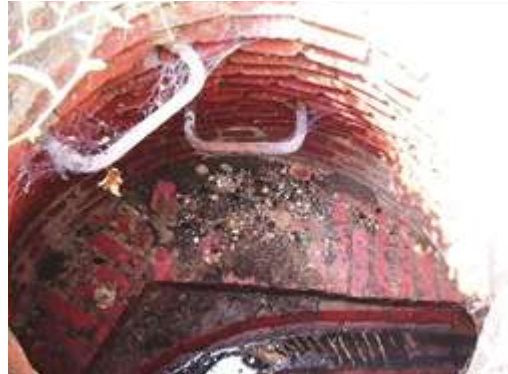
Defect

Adjustment deterioration and infiltration. Corbel and Barrel infiltration - Bench debris.

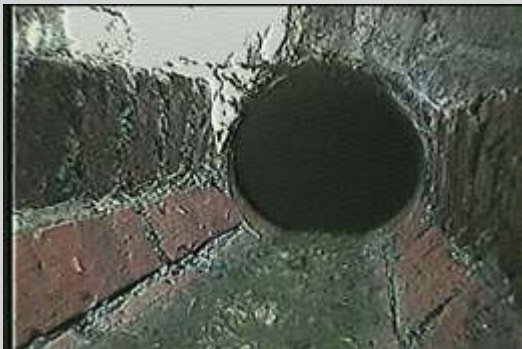
8 in. Circular Gravity Sewer Pipe In @ 7 O'Clock

Channel deterioration.

Infiltration: **Evidence** Pipe Seal Cond: **Cracked**
